EXHIBIT H

Degradation of polypropylene in the human eye: A sem-study

W.L. JONGEBLOED¹ and J.F.G. WORST²

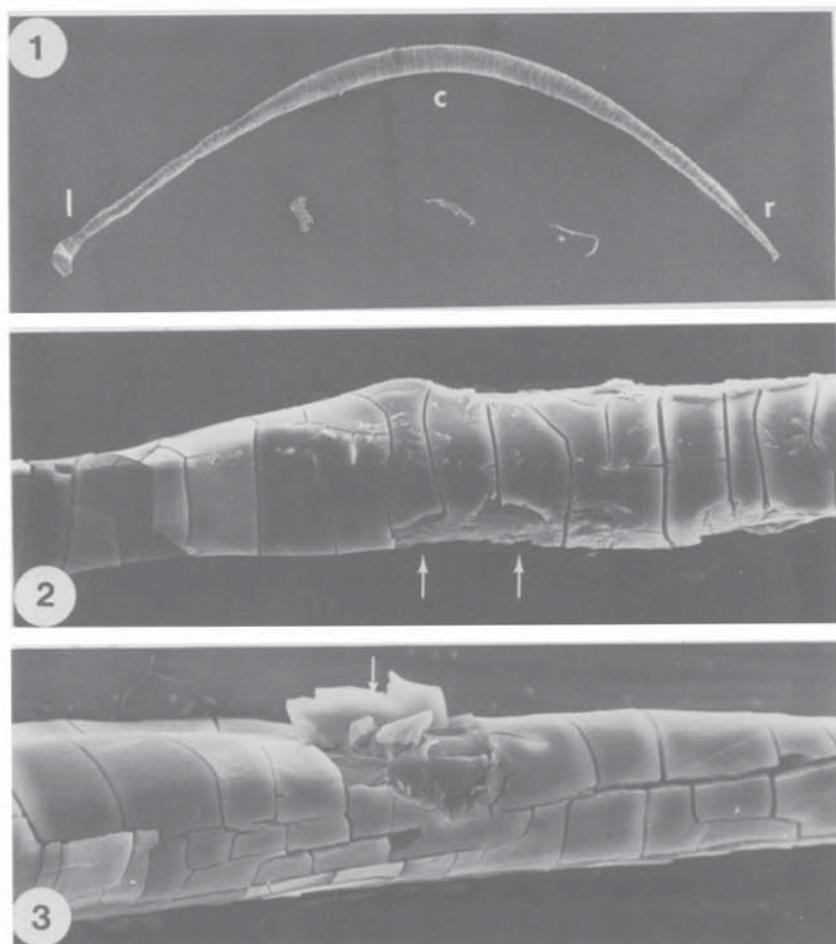
The polypropylene suture which had been in the human eye for 6½ years as fixation suture for an IOL is shown at low magnification in Figure 1. The left end (l) and the right end (r) of the suture show a considerable decrease in suture diameter in comparison with the central part (c). The right end had spontaneously broken, while the left end was cut off to free it from the surrounding tissue.

Figures 2 and 3 represent parts of the left side of the suture, cracks perpendicular to the longitudinal axis of the suture are visible. Lumps of the surface layer are nearly detached or are already missing (arrows). Note also the irregularity of the diameter of the suture in both pictures.

Figure 1. Polypropylene suture which remained for $6\frac{1}{2}$ years in a human eye as a fixation suture; l = cut-off end, diameter appr. $100\ \mu\text{m}$; r = spontaneously broken off end, diameter appr. $60\ \mu\text{m}$; c = central part, not in direct contact with tissue, diameter $200\ \mu\text{m}$. Magn. $20\times$.

Figure 2. Part of left side of suture of Figure 1, showing cracks in surface layer and missing part of surface layer (arrows); note irregular diameter. Magn. $225\times$.

Figure 3. Part of left side of suture of Figure 1, showing cracks in surface layer and nearly detached lump of surface layer (arrow); note somewhat twisted shape of suture. Magn. $325\times$.

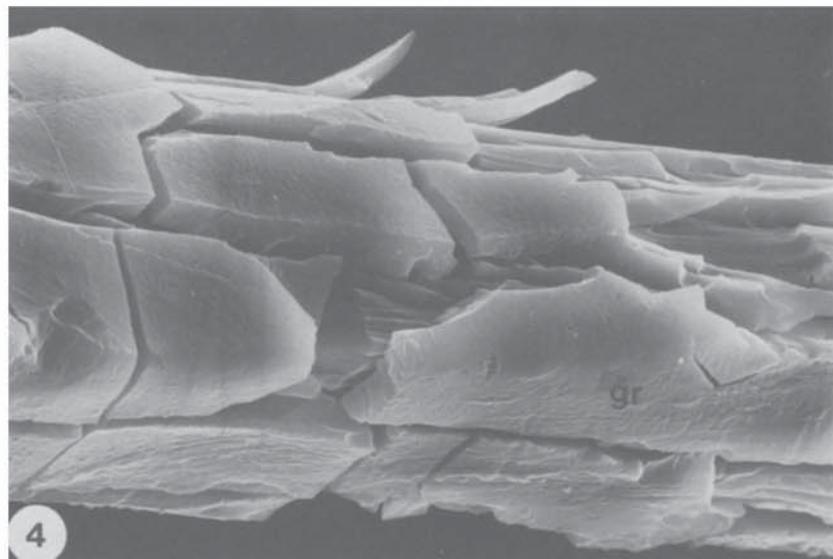
Figures 4 and 5 also represent parts of the left side of the used suture of Figure 1. The cracking of the surface layer is very obvious in Figure 4; almost the complete surface layer has been split off from the underlying layer. The outer surface of the lumps is covered with a thin layer of probably organic material with a slightly granular appearance (Figure 4). Closer to the central part of the suture (the part which was not in direct contact with the tissue) the disintegration of the polypropylene appears to be considerably less extensive. Figure 5 represents a part of the suture left of the centre, the cracks in the surface layer are already present and the diameter decreases towards the left side of the suture.

Figure 4. Part of left side of suture of Figure 1 showing completely disintegrated surface layer, large lumps nearly detached. Magn. 1000 \times .

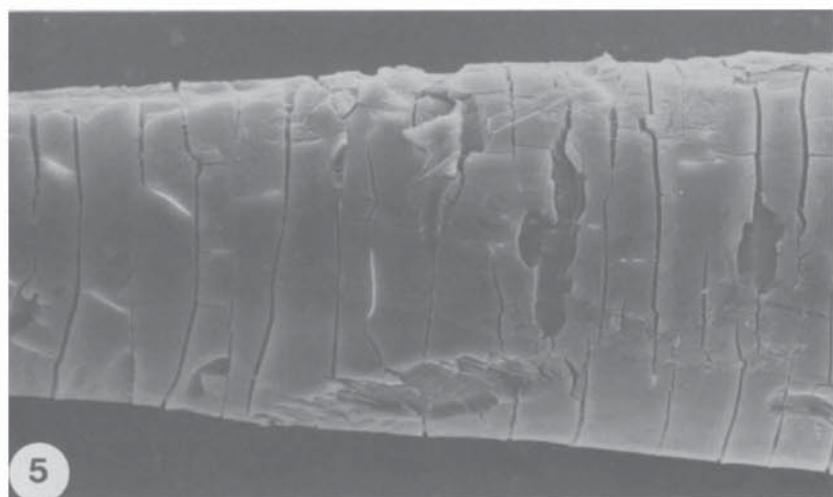
Figure 5. Part of left side of suture of Figure 1, close to central part of suture. Surface less attacked; note decreasing diameter towards left side. Magn. 300 \times .

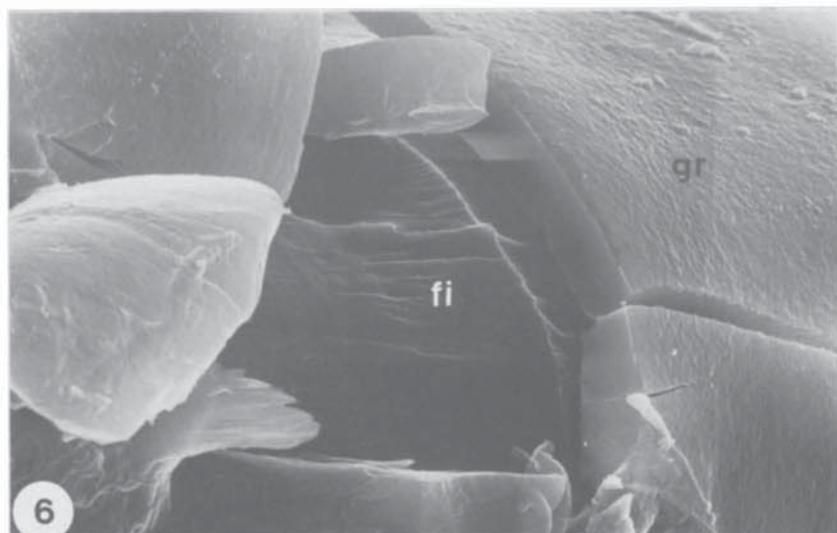
Figures 6 and 7 represent details of Figures 3 and 4 respectively, showing the subsurface layer after splitting off of the lumps of the surface layer. The subsurface layer shows a fibrillar character and the splitting off

Figure 6. Detail of Figure 3 showing subsurface layer with fibrillar character (fi); note thin organic deposit with granular character (gr) on outside of lumps of surface layer. Magn. 2000 \times .

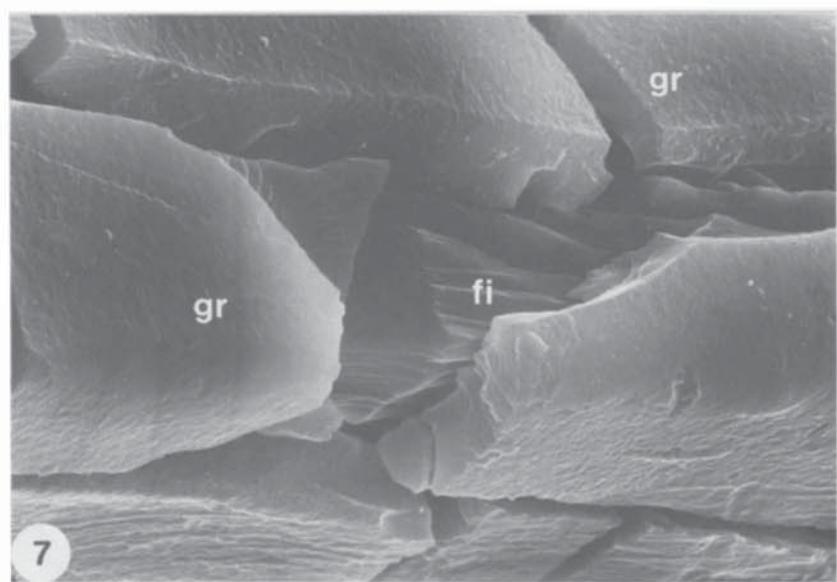
of the surface layer is clearly observable. The outside of the lumps of the surface layer is covered with a thin layer of organic material with a slightly granular appearance.

Figure 7. Detail of Figure 4 showing splitting of surface layer from underlying layer with fibrillar appearance (fi); lumps covered with somewhat granular material (gr). Magn. 2000 \times .

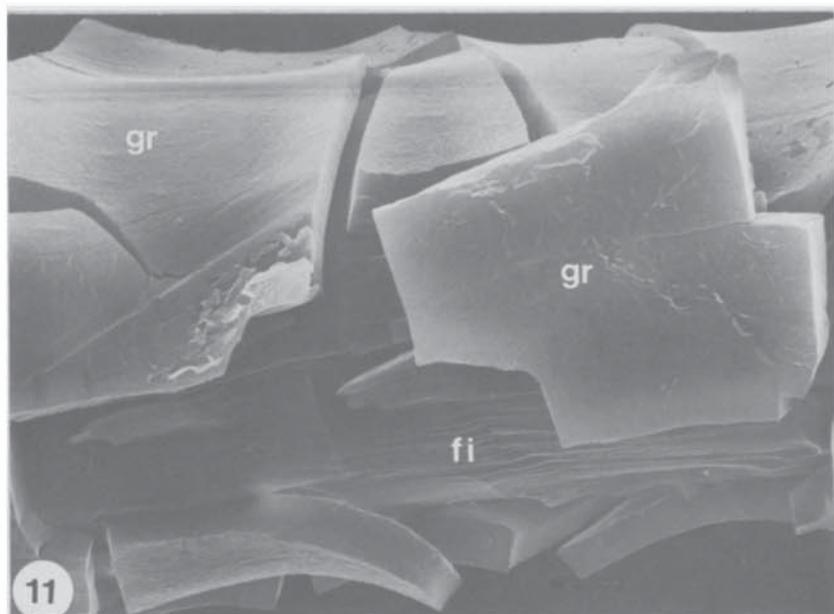
Figure 11 shows the destruction of the polypropylene in a rather dramatic way; the complete surface layer has broken into pieces, exposing the subsurface layer. The outside layer is covered with some deposits, mainly of a granular nature.

Figure 11. Part of right side of suture of Figure 1 showing almost complete degradation of surface layer, large lumps have detached exposing subsurface layer with fibrillar character (fi). Note granular deposit on lumps (gr). Magn. 975 \times .

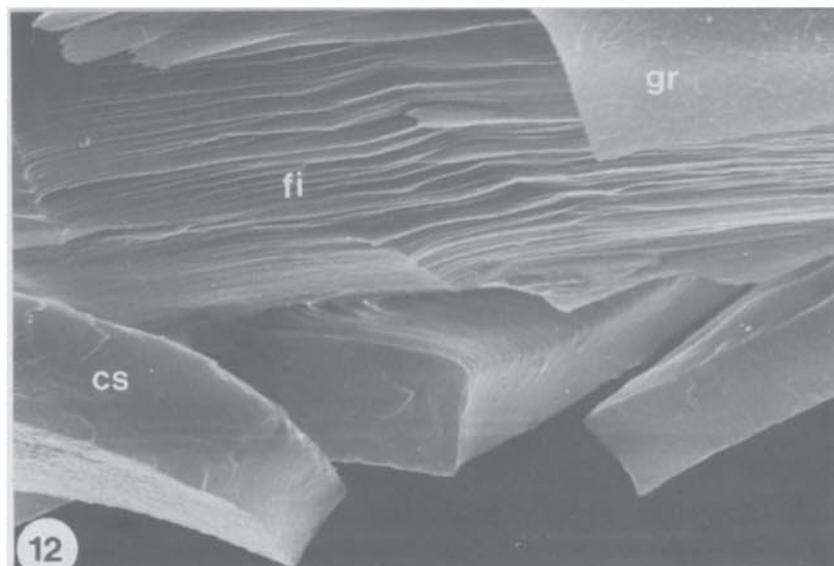
The subsurface layer is observable in more detail in Figure 12 (detail of Figure 11); the fibrillar character of this layer is clearly visible, while the splitting of the surface layer is noticeable, particularly at the cross-sections of the split-off lumps in the lower part of the picture.

Figure 12. Detail of Figure 11 showing subsurface layer (fi) and split-off lumps of surface layer in more detail (cs). Magn. 2500 \times .

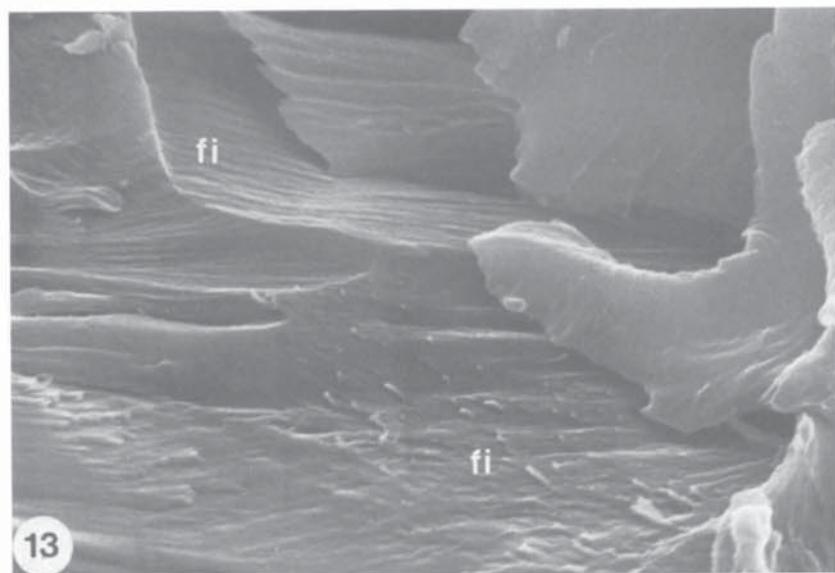
The fibrillar character of the subsurface layer, and the irregular splitting of the surface layer from the underlying layer as the result of a chemical change in the surface layer, are shown in more detail in Figure 13.

Figure 13. High magnification of subsurface layer after detachment of surface layer; note irregular splitting effect due to chemical change in polypropylene. Fibrillar character (fi) of subsurface layer clearly observable. Magn. 5000 \times .

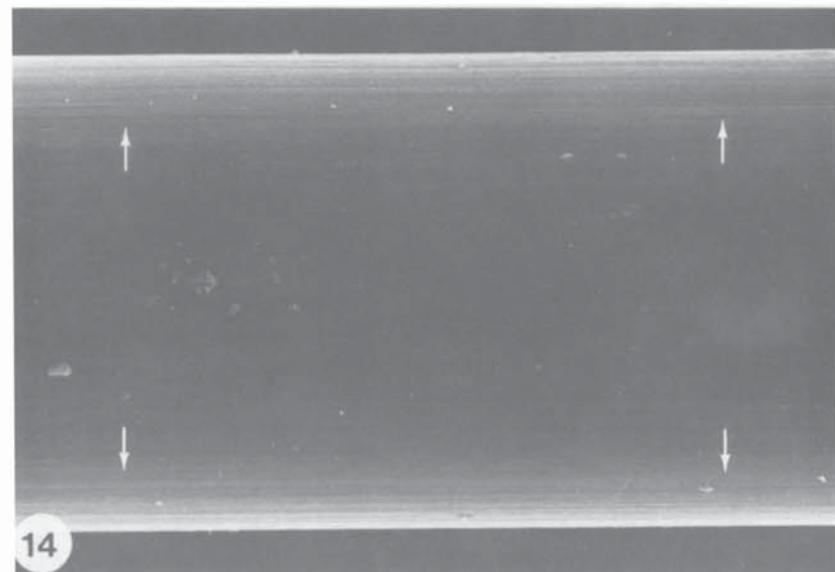
In a virgin piece of surgical polypropylene, taken from an intact package, none of the phenomena described above are observable (Figure 14). The diameter is 200 μm and only thin grooves due to the manufacturing process are visible running along a very smooth surface (arrows).

Figure 14. Virgin piece of polypropylene from a surgical packet, prepared for SEM in exactly the same way as the suture of Figure 1, showing no degradation at all; note manufacturing grooves (arrows). Magn. 300 \times .
